CONSTRUCTION WORKPLACE DESIGN SOLUTION

Roof Hatch Access and Hole Protection

HAZARD: FALLS

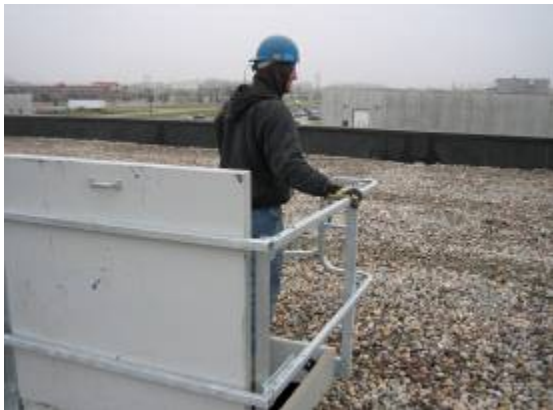
Guardrail, swing gate, and grab bars

2. Serious risk of a worker toppling into the unguarded opening of the roof hatch and falling as much as 30 feet down the ladder. The roof hatch constitutes a floor or roof opening which should be protected. The use of 42 inch high guardrails around the open sides of the roof hatch reduces the risk of this type of fall. Additionally, hatch access grab bars can be built or added, and access made with an integral swing gate which opens away from the ladder opening. These controls will also help to prevent falls resulting from the curb acting as a tripping point for forward and backward movement when the hatch cover is open.

1926.502(a)(13). Guardrails, swing gates, offset railings to avoid walking into floor openings.

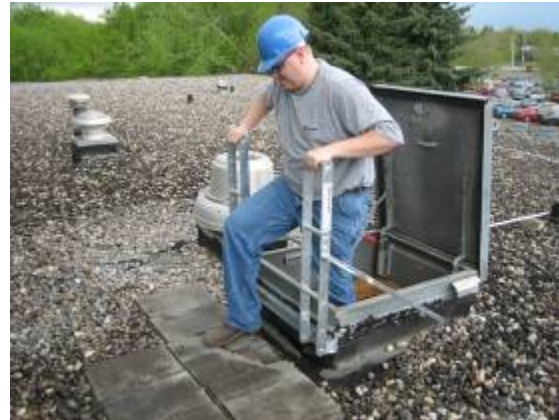
Horizontal grab bars

1926.1053(a)(27). Horizontal grab bars spaced by continuation of rung spacings, or vertical grab bars shall have the same lateral spacing as the side rails*.

- * Research conducted by the University of Michigan Center for Ergonomics indicates that free falling arrest is most successful and reliable when holding horizontal handholds and that free falling with vertical handholds is not successful in arresting falls. See article referenced below.
